# Porch Exterior Condition Assessment — Paint and Hardware

A walkthrough of a residential porch exterior identified three defect categories: peeling paint on the overhead soffit/fascia, missing door hardware, and widespread paint cracking along the house siding. All defects are on the exterior painted surfaces.

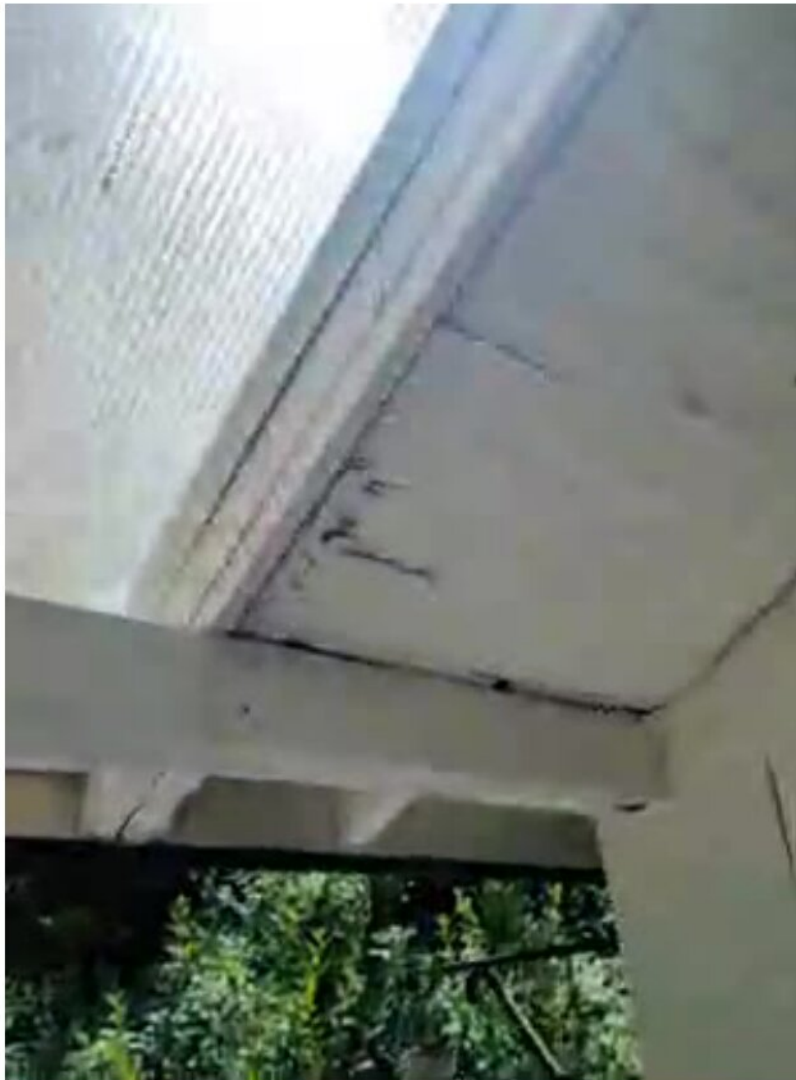
The porch overhead soffit and fascia boards show significant paint failure. Multiple sections exhibit peeling and lifting paint, with curled flakes visible along the fascia edge.

peeling paint along fascia underside

Scraping and repainting of the soffit and fascia is required; substrate condition beneath the peeling paint should be assessed for moisture damage prior to repainting.

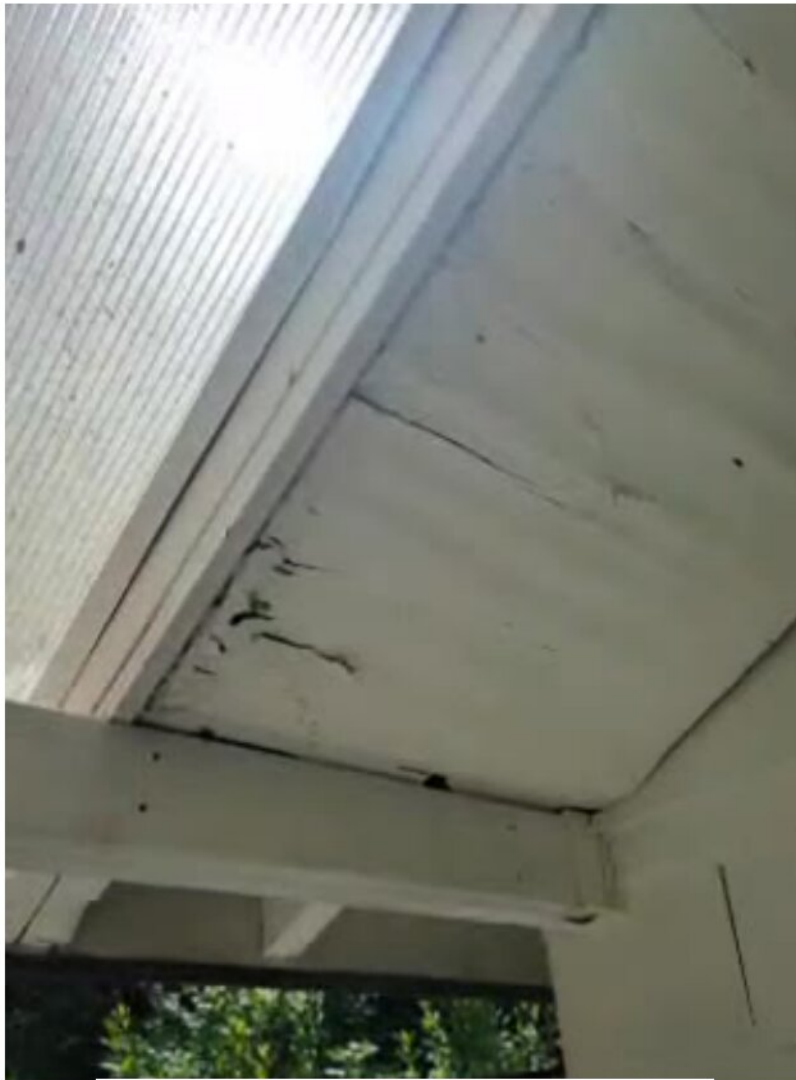
The defect extends across the full visible length of the soffit, with paint separating in strips rather than isolated flakes.

curled paint strips on soffit near beam junction

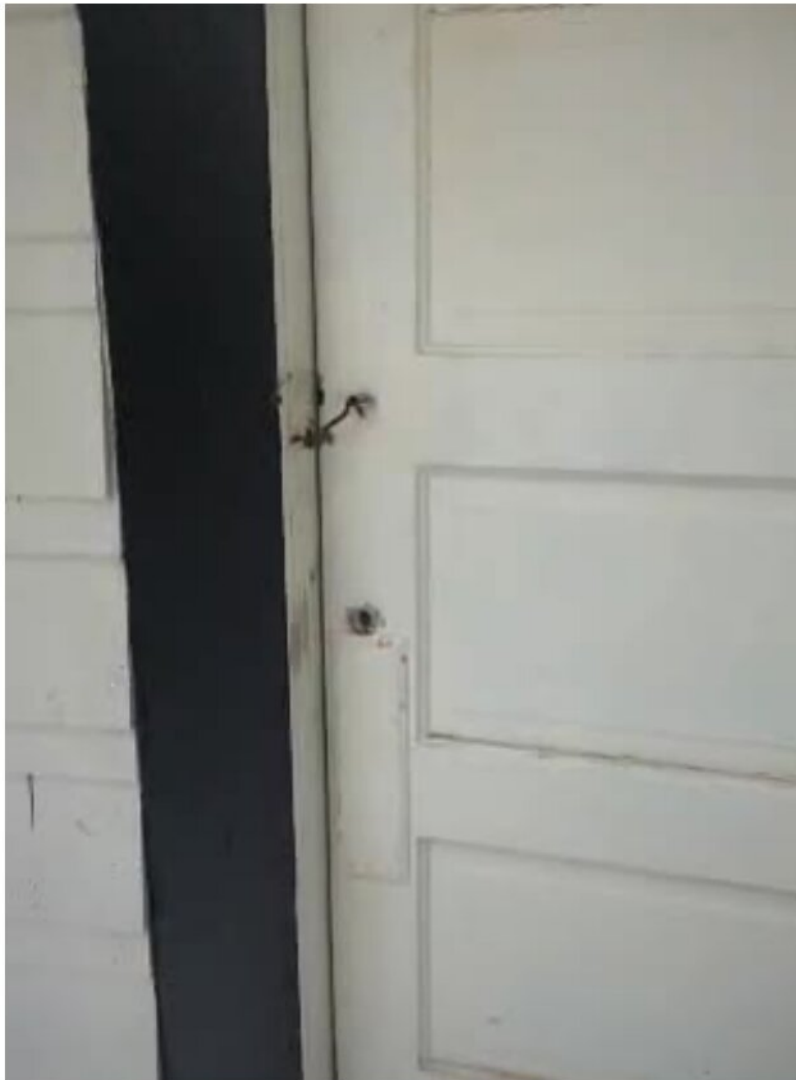
The porch door is missing its handle set. A latch mechanism and a mounting hole are visible, but no handle is present on either face of the door.

door edge showing latch and empty handle mounting hole

Replacement hardware should be sourced to match the existing latch configuration.

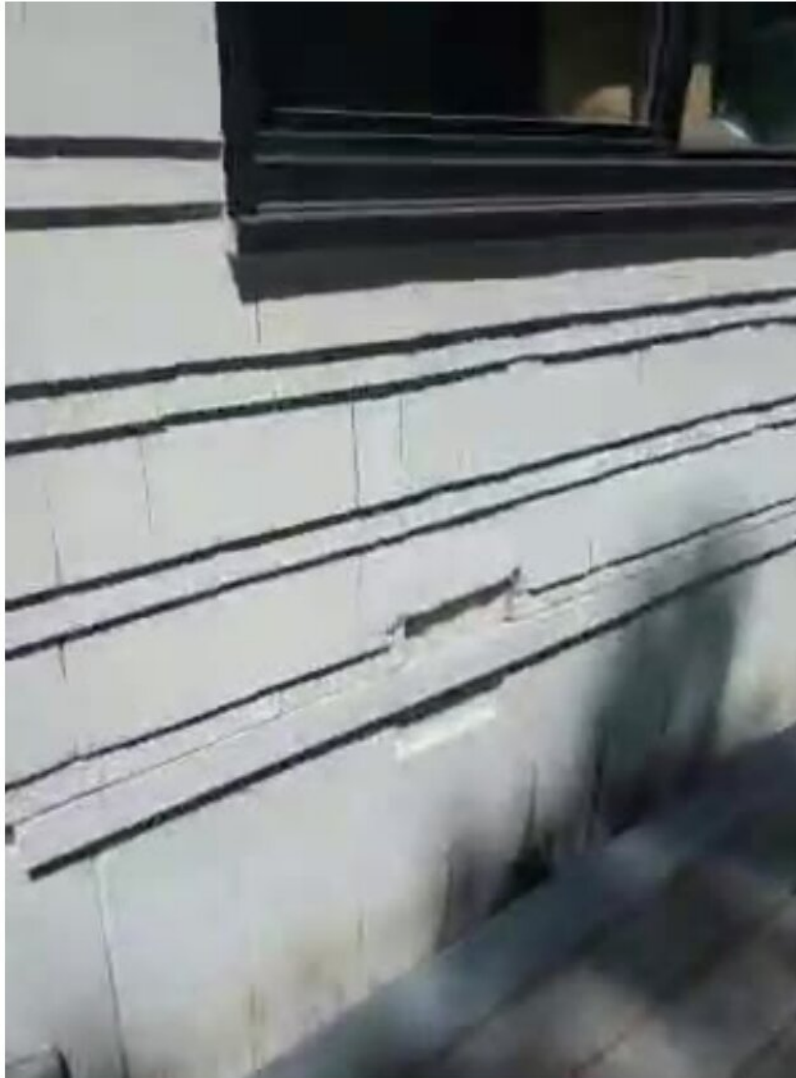
The painted horizontal siding along the house exterior shows widespread cracking and paint separation. Cracks run horizontally along siding joints and vertically through individual boards.

horizontal siding with cracking paint along joint lines

Full-surface scraping, priming, and repainting of the affected siding sections is indicated. The extent of bare wood exposure should be checked for weathering or rot.

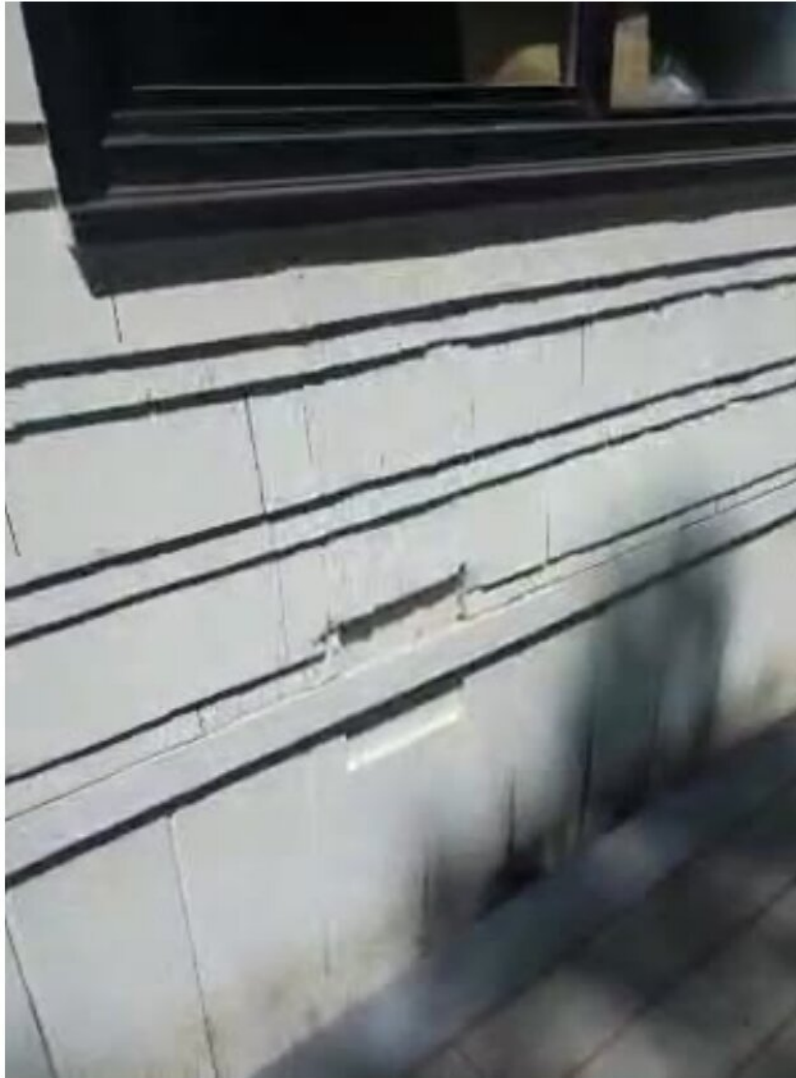
The defect is present at multiple elevations and extends beyond the immediate porch area.

close view of cracked and separating paint on lower siding courses

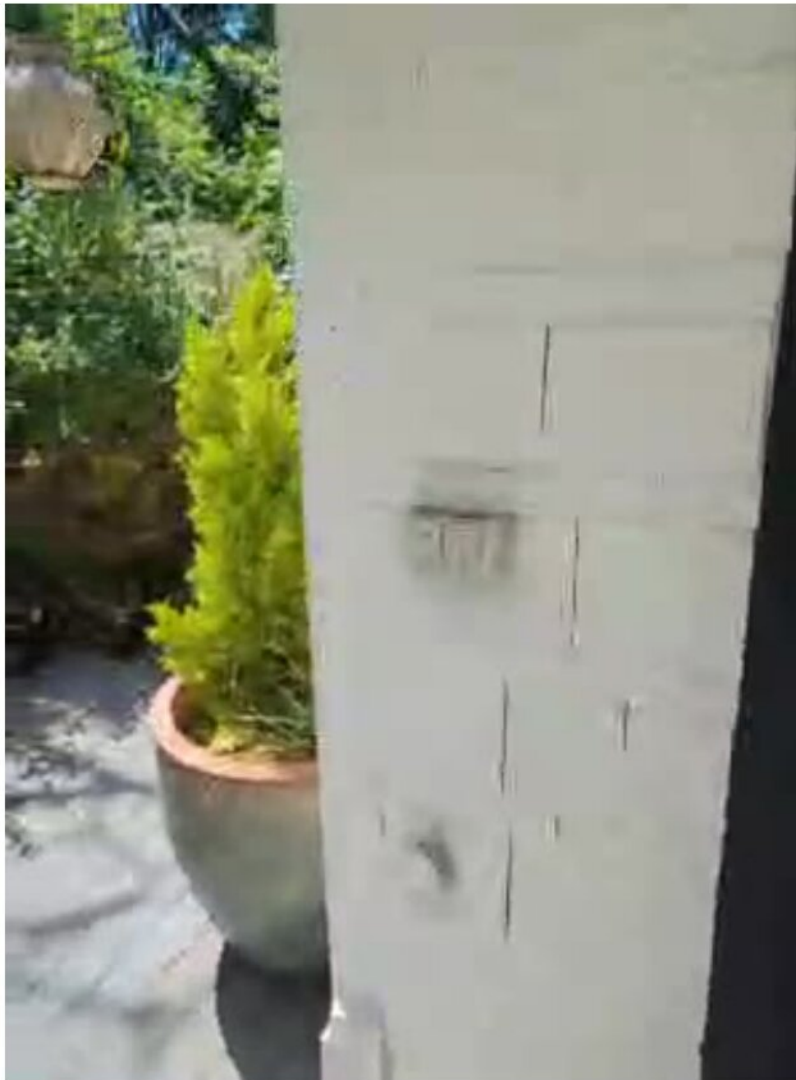
The painted porch column also shows surface cracking consistent with the siding defects. Vertical and horizontal crack lines are visible across the column face.

close view of column face with cracking paint

The column appears structurally intact, but the paint layer is failing and will require preparation and recoating.
